Proceedings of the ASME 2009 International Design Engineering Technical Conferences & Computers and Information in Engineering Conference IDETC/CIE 2009 August 30 - September 2, 2009, San Diego, California, USA

DEC2009-86307

DRAFT: DIAGNOSIS AND TREATMENT OF BOWED, MISALIGN, AND ECCENTRIC ROTOR TRAINS

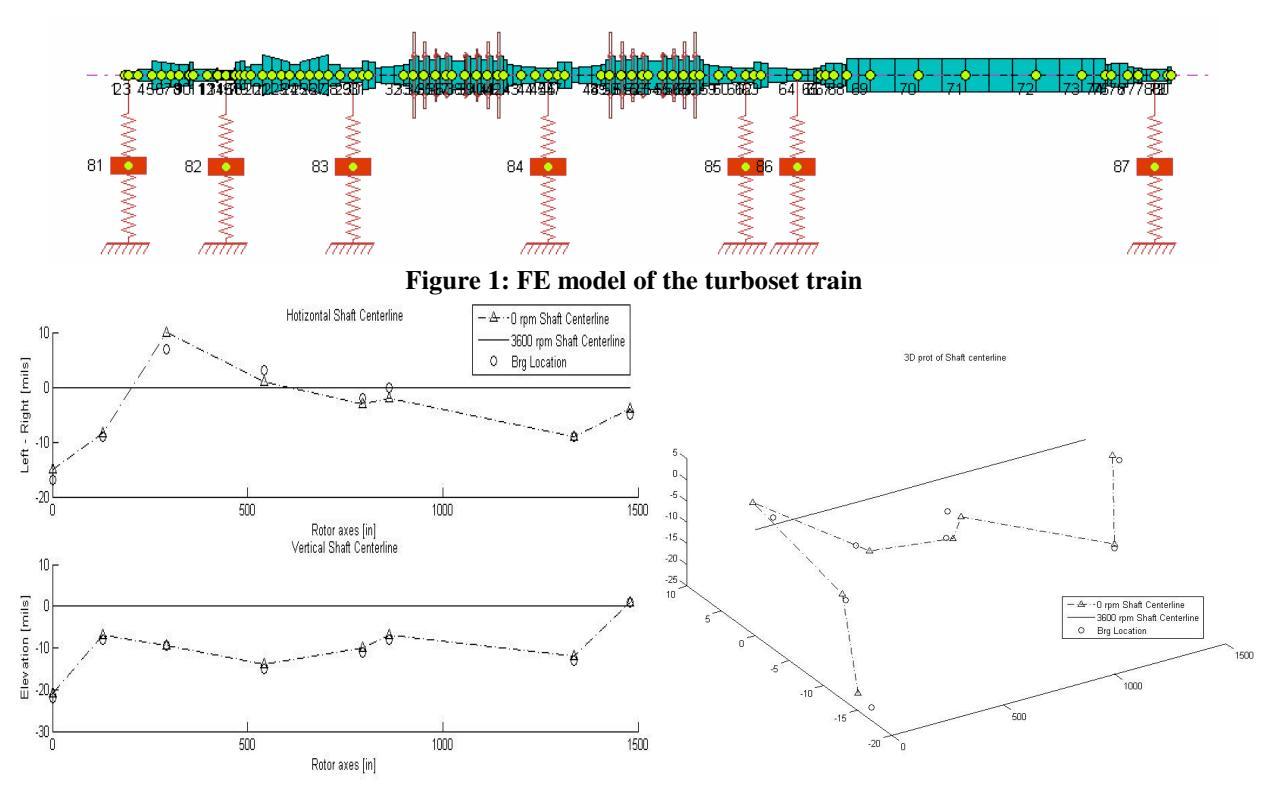
Figure 2: Journal and Bearing Centerline at Stand Still

A 3D plot, 2D vertical and 2D horizontal views of the reconstructed journal and bearing centerline are shown in Figure 2.

The solid line (0-0 line) represents the journal centerline as measured by the proximity probe gap at full speed (normalized with respect to the catenary). This line becomes the reference line for the remaining analysis. The dashed line represents the journal centerline as calculated based on probe gaps at turning gear (4~10 rpm) and the circles represent the bearing centerline (0 rpm).

It is clear that a straight rotor can not fit the dashed line that represent the journal centerline at turning gear or at stand still (circles) therefore the rotor has to be deformed at stand still (bowed misaligned or eccentric in some manner) in order to fit the observed configuration.

The present journal centerline analysis confirms the previous diagnosis, in addition, it is possible to estimate the amount of bow based on the centerline plot by fitting bowed rotors. Based on the best fit of a bowed rotor and geometric considerations the amount of bow at the HP and IP rotors were estimated in 0.002" and 0.004" respectively, in opposite angular directions. It was also found that the HI-IP and the IP-LP couplings had some degree of unperpendicularity but no estimation was possible on

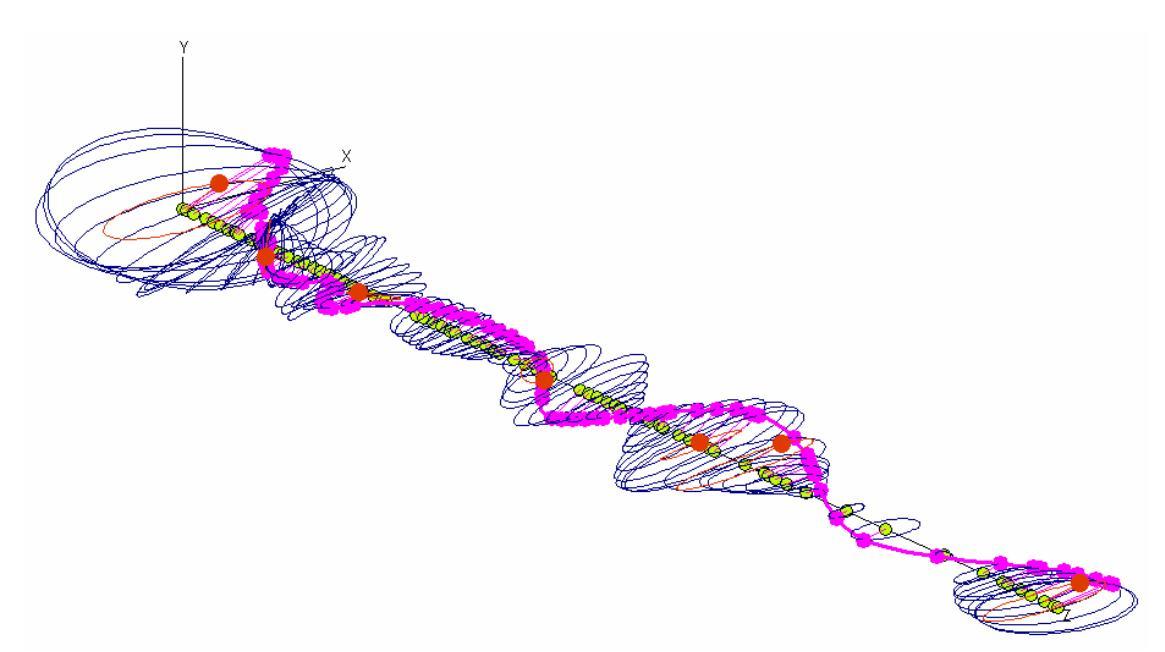
Figure 3: Synchronous rotor response to IP bow and coupling angular misalignment

In order to verify the existence of a bow and to analyze its possible remedy a computer model was created. A picture of the model is shown on Figure 1. Several scenarios were investigated, including HP and IP rotor bow and coupling misalignment. As a result of this, it was establish that the likely cause of the observed behavior was an IP rotor bow and a coupling angular misalignment between the IP and LP1 rotors. Figure 3 shows the result of the computer simulation. The magnitude of the stress at the #1 bearing babbitt produced by the simulated bow exceeds the yielding point of the material for the operating temperature which explains the #1 bearing failure rate.

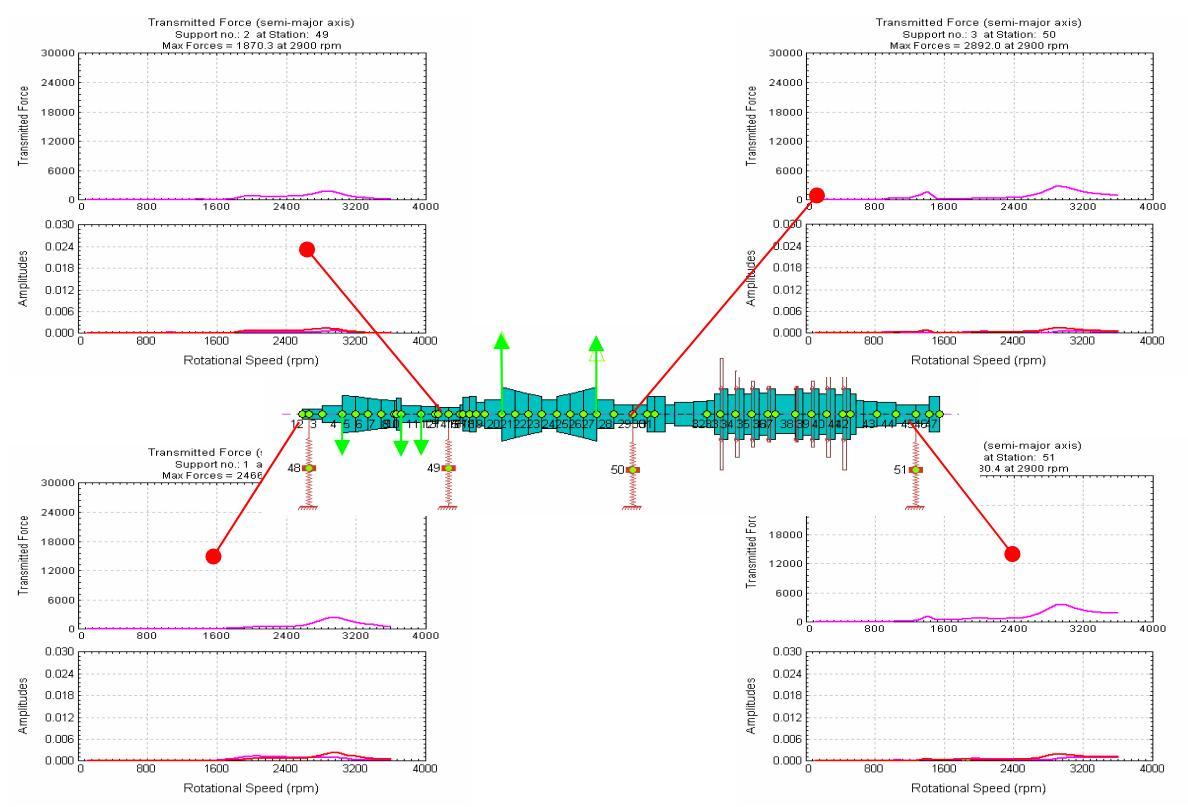
Figure 6: Journal centerline correction and high speed balancing

From this analysis it is clear that the best course of action was to move the journal centerline of the rotors followed by high speed balance of each individual rotor. Although in theory there is no need to correct the journal centerline of the rotors and simply balancing them will produce a satisfactory result, in reality this is not possible. In order to perfectly balance the rotors an infinite number of balancing plane is needed; the subject HP and IP rotors only have 3 and 2 balancing planes available for balancing respectively. This is the reason why, not only for the subject rotors but for many others, balancing is not a real option when correcting a bow and, therefore, corrective machining is needed.

Computer simulation of balancing, coupling corrective machining plus balancing, and journal centerline correction plus balancing are shown below in Figure 4, Figure 5, and Figure 6 respectively. In each case, the calculated displacement bode plots and bearing forces are shown.

As a result of the optimization it was establish that the HP front journal had to be moved 0.0018" in the direction of the existing bow and that the IP dummy journal and coupling fit need to be moved 0.0040" also in the direction of its bow. The remaining HP rear and IP rear bearings were not moved. If we recall that these rotors weight ~20000Lb and ~50000Lb respectively it becomes clear the technical difficulty of handling and accomplishing such small moves of their centers of rotation.

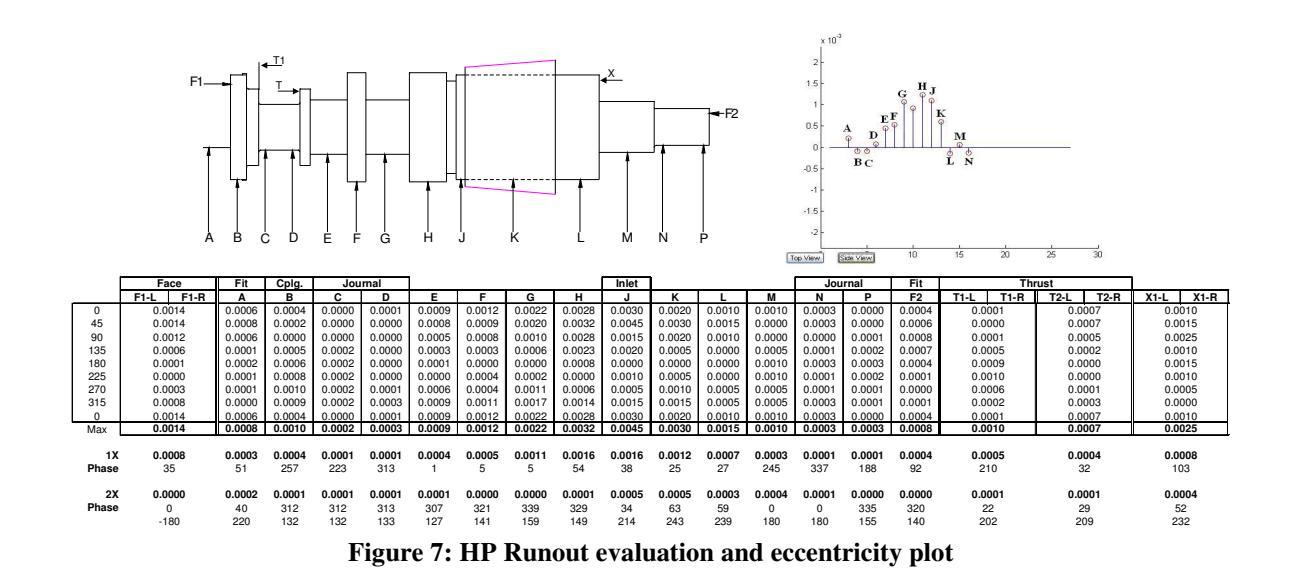
several locations along the rotor length. In order to evaluate the runouts and be able to produce an eccentricity plot each individual sets of runouts is filter with a once and a twice per revolution filter that separate the eccentricity portion of the runout from the out of roundness and 2 pole effect in the case of 2 pole generators. Racic and Hidalgo [8,9]. This procedure can be used to evaluate any kind of rotor where concentricity and out of roundness are of concern. The runout evaluation and eccentricity plots are shown in Figure 7 and Figure 8.

The bow can easily be seen in both figures confirming the previous diagnosis. Opposite to what was diagnosed the magnitude of the bow in the IP case was only half of its prediction, the main reason of discrepancy is the fact that the coupling between the HP and IP rotors was badly off-square from cyclic bending stress and this cannot be seen in the diagnose.

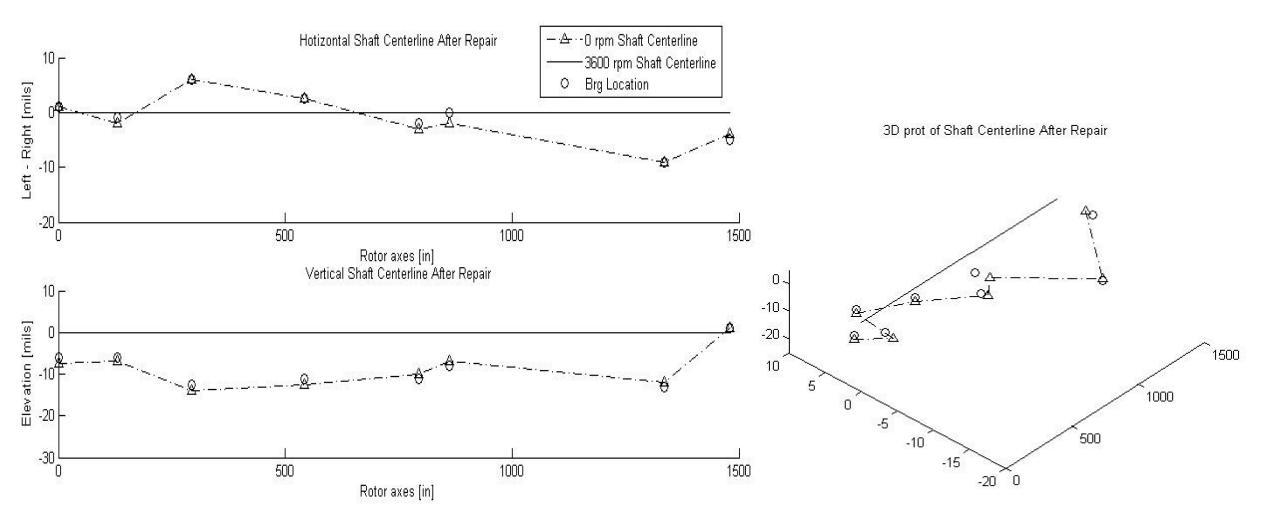
Figure 9: Journal and Bearing Centerline at Stand Still After Repairs

In order to evaluate the new alignment condition we followed the same shaft centerline reconstruction procedure described earlier on section 3. The results shown in Figure 9 use the same scale for an easier comparison. Since only the HP and IP turbines were realigned, leaving the LPs and rest of the train unchanged, the main change can be seen at the HP and IP turbines. It is now clear that this is not an optimal alignment and that further improvements in vibrations can be achieved if the turboset were realigned as a unit and the swing check performed. In addition to the full realignment removing some of the LP1 balance weights will improve the machine running condition as some of these correction weights were put to compensate for the IP-HP bow prior to this outage and are no longer needed.

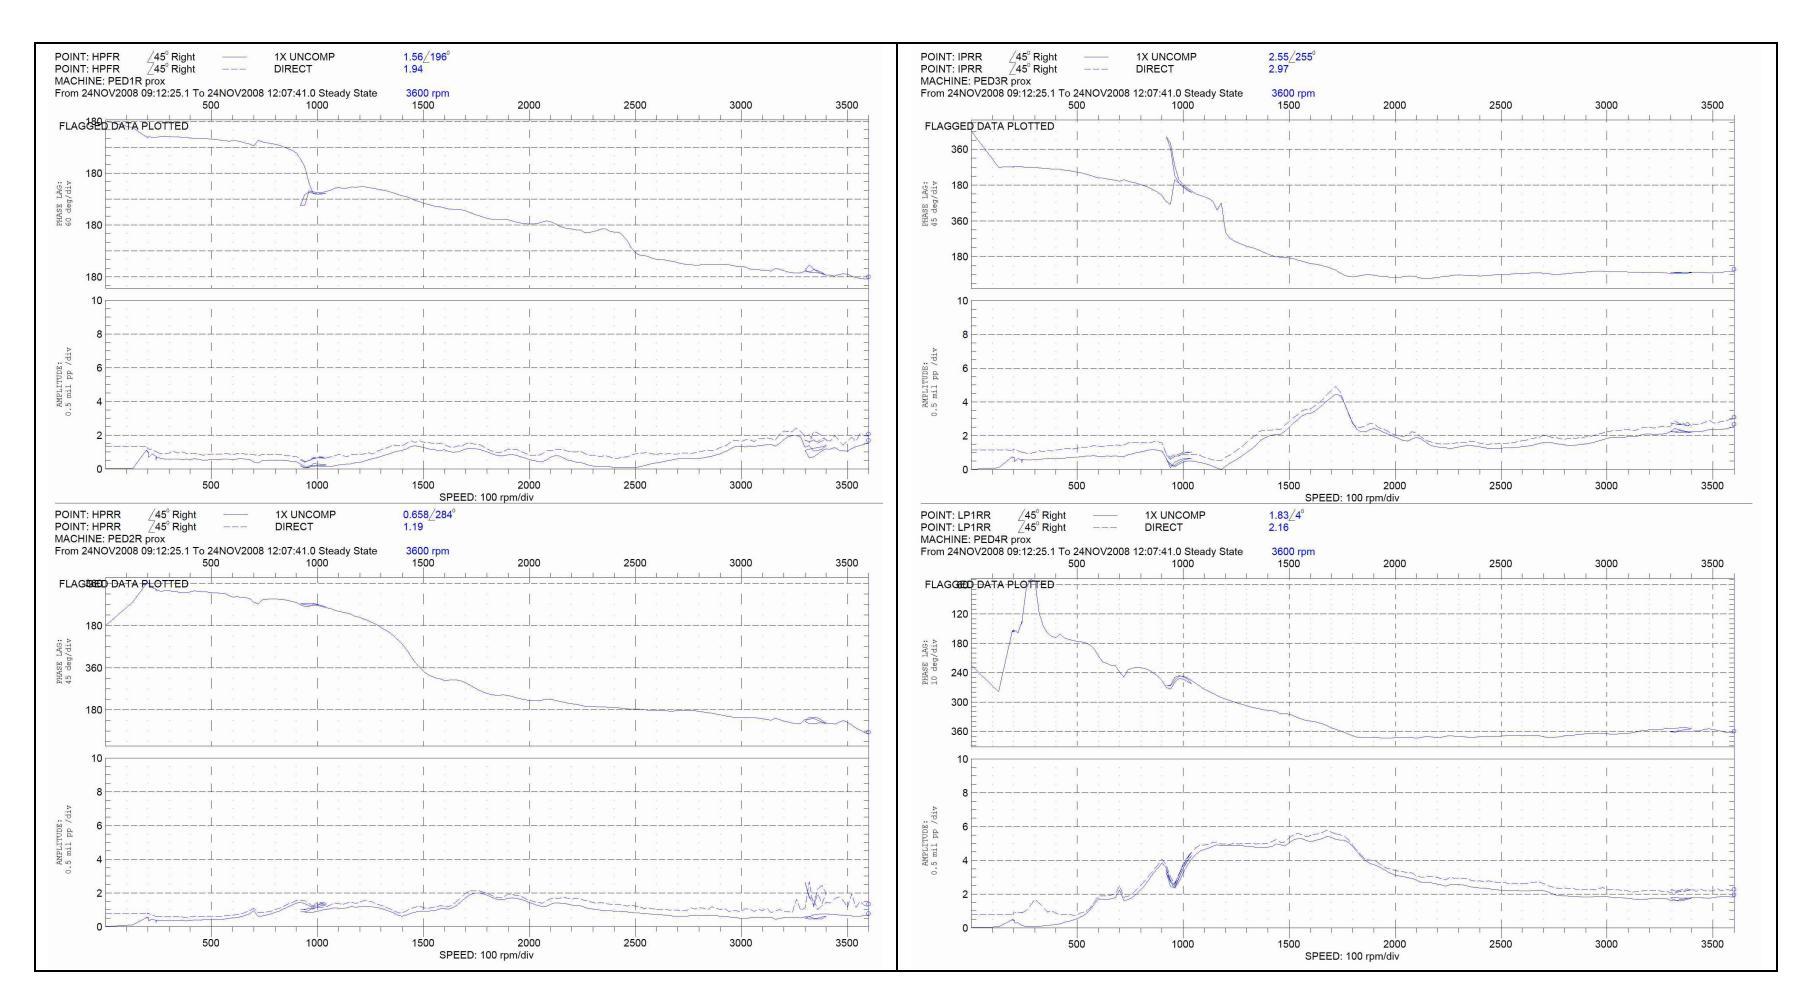
Figure 10: Start up bode plots of the HP, IP, and LP-1 turbine rotors

not done. Nevertheless first roll up to speed resulted in excellent vibration levels as can be seen in Figure 10 indicating excellent mechanical condition of the repaired rotors. As the machine was loaded and it warmed up, the vibration levels increased to the values shown on Table 2. This is not unusual on turbosets, when the rotor train and casing fully expand and every bearing finds its final position due to thermal expansion, vibration usually changes as the hot bearing and casing alignment will be different from the cold one; on the other hand the machine is now operated under full electrical and steam loads that produce additional external forces.
