Presented at 8th International EPRI Conference- Welding & Repair Technology for Power
Plants, Fort Myers, FL, June, 18-20, 2008

**REFURBISHMENT OF CRACKED LP SPINDLE
RIVERSIDE STATION, UNIT 2, PPG INDUSTRIES**

Abstract

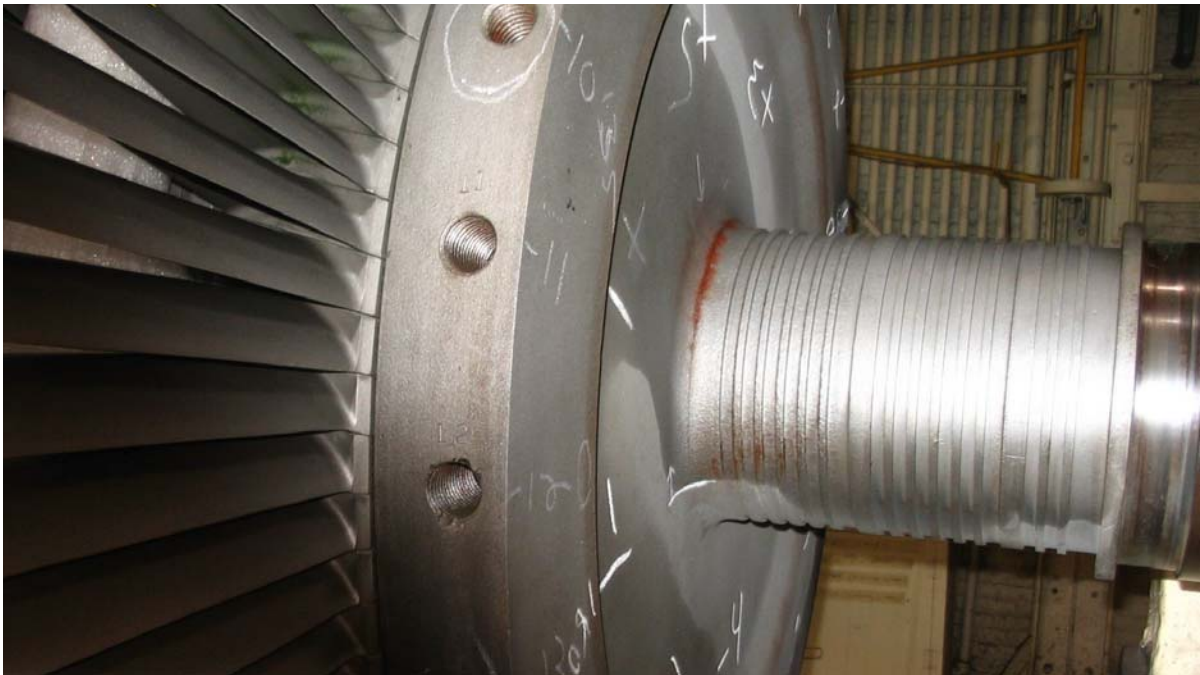
Figure 1. A circumferential-radial crack is visible at the steam gland radius on the HP spindle end (red dye). The crack extended about 270° around the circumference, and extended into the bore.

The center of the LP spindle was supported during shipment since the steam gland crack depth was unknown, and the cold weather (0°F) could have produced a brittle fracture causing the LP spindle to drop and bend the blades. Figure 1 shows a 270° circumferential crack at the steam gland radius. The center of the crack was positioned at 6 o'clock, and a cutoff wheel was used to separate the two pieces by grinding from the OD at the 12 o'clock position toward the crack tip. After sufficient material had been ground away an upward pull on the coupling caused a brittle fracture of the remaining ligament. The coupling side crack surface is shown in Figure 2. The smooth surface features with concentric marking identify the crack mechanism as bending fatigue or corrosion-bending fatigue. The crack propagated into the bore, but the crack was not as deep as indicated on the OD (270°); about 50% of the cross section was cracked. Corrosion pits were present on the steam gland radius where the fatigue crack initiated. These pits act as stress concentrators and this is probably the reason for fatigue crack initiation.

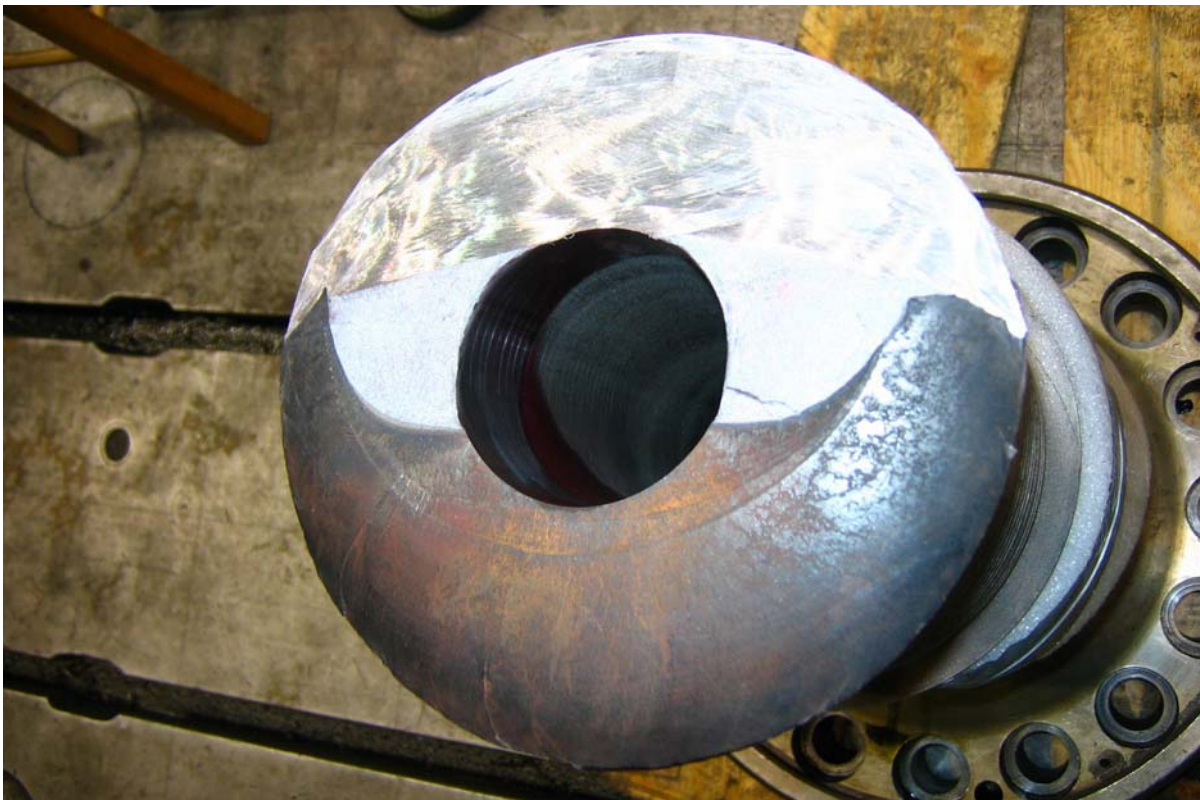
Figure 2. The crack was opened after being ground down at 12 o'clock and subsequent brittle fracture. The smooth fracture features indicate a fatigue failure with the origin at about 6 o'clock.

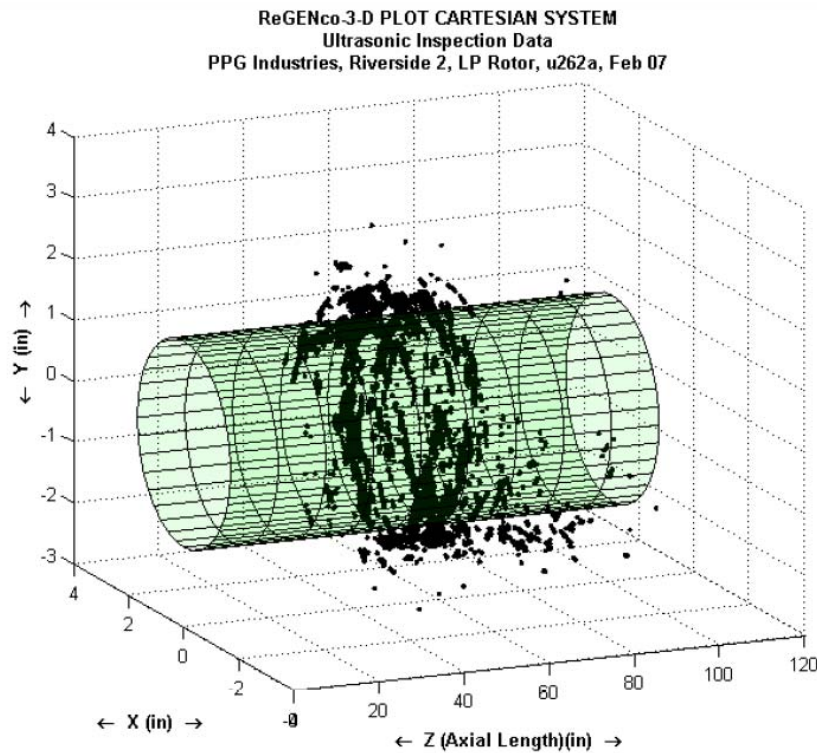
Figure 3. Original Boresonic UT CW&CCW Data Before Overbore

The initial boresonic vendor performed boresonic inspection on the LP spindle and reported more than 100,000 UT indications concentrated at about 45 to 106 inches from the governor end. Bore indications were present at the circumferential crack location, which was about 100 inches from the governor end. Since UT data was not filtered for target motion lines, about 93,000 were found to be duplicate indications and 11,582 indications were considered significant as shown in Figure 3. The UT indications were detected using clockwise & counterclockwise search units that can detect axial-radial cracks, which are the most serious since these flaws can grow and burst the forging without any prior warnings.

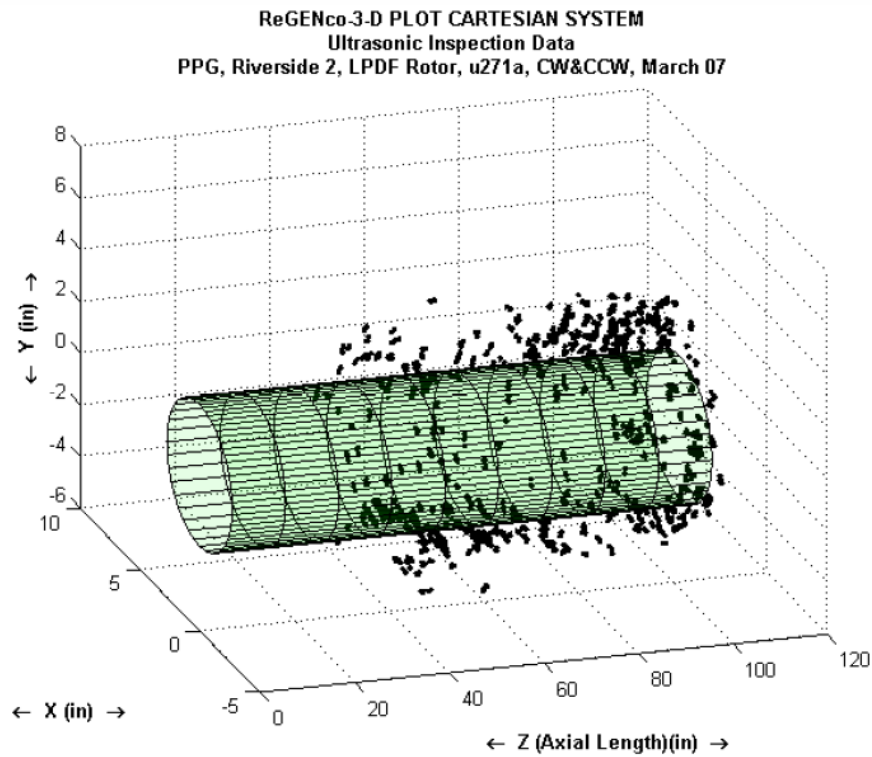
Figure 4. Final Boresonic UT CW&CCW Data After Overbore

ReGENco conducted a condition assessment of the LP spindle based on these data. This assessment included sizing of potential flaws from UT, material evaluation, stress analysis, and fracture mechanics analysis. A cluster analysis was performed on the UT data to group the indications located in a user specified envelope. These clusters can then be individually observed for crack-like pattern and sized for depth and length. Based on the size of these flaws, a fracture mechanics and probabilistic analysis can then determine the service life or inspection interval for the spindle (Ref 1). The analysis resulted in several serious cluster flaws, which were detrimental to the integrity of the spindle forging. The LP spindle bore was then machined to a larger specified diameter all along its length. WesDyne International re-examined the LP spindle and the results are shown in Figure 4. Again, ReGENco conducted a condition assessment of LP spindle based on the WesDyne data. All serious indications were machined out. It was recommended that the LP spindle could be put back into service and run for more than 20 years before next bore inspection.

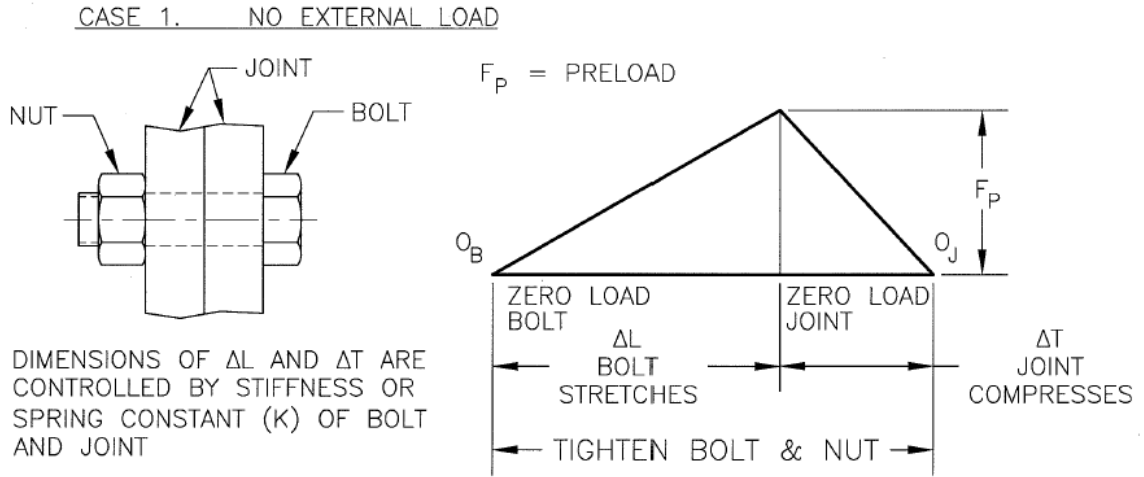
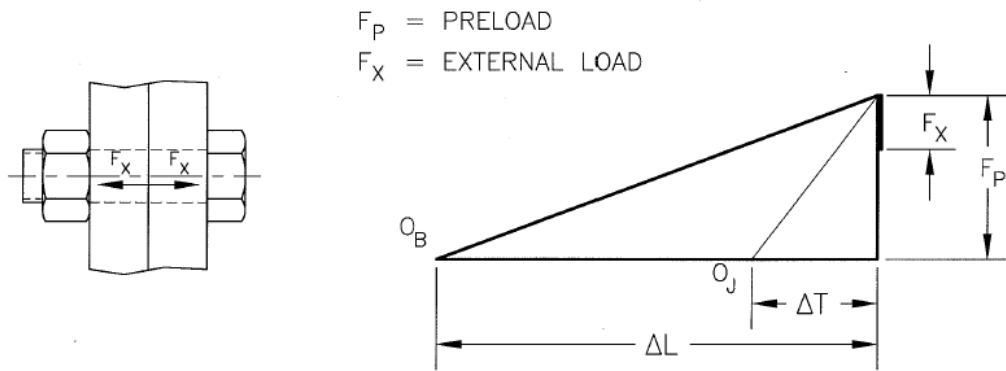
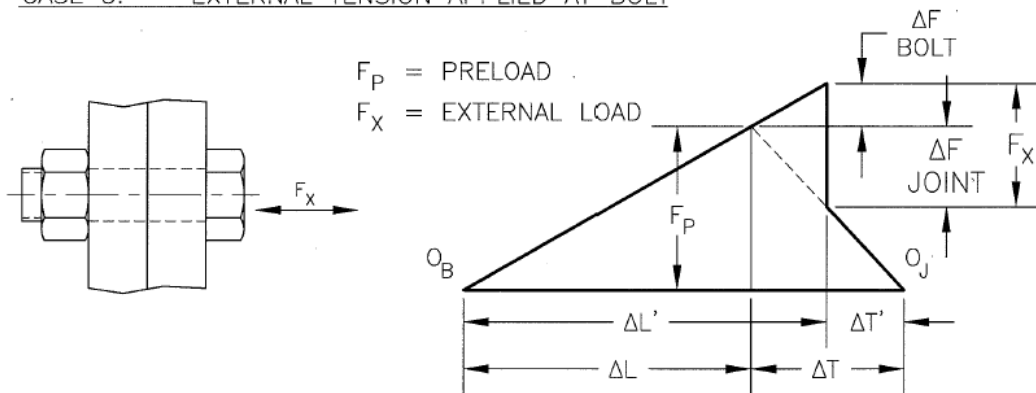
CASE 2. EXTERNAL TENSION APPLIED AT JOINT INTERFACE

CASE 3. EXTERNAL TENSION APPLIED AT BOLT

Figure 6. Various Types Of Loading On Bolted Joints

There is a big difference between a bolt loading if the external load is applied at the joint interface or if it is applied at the bolt as shown in Figure 6. Case 1 illustrates a joint that is bolted together without an external load, whereas Cases 2 and 3 illustrate two types of external loads on a bolted joint. The displacement dimensions ΔL (bolt) and ΔT (joint) depend on the stiffness, or spring constant, of the bolt and joint. For the cases presented herein the stiffness of the bolt is less than the stiffness of the joint, which is always desired if fatigue loading is present.

If a bolted joint is loaded due to external load at the joint interface, as shown in Case 2, then any external load on the bolt (F_x) can be completely suppressed with adequate preload (F_p). In order for the joint to separate, the external load at the interface would need to be greater than the bolt preload. However, if the external load is applied to the bolt (F_x) instead, as shown in Case 3, then the load that the bolt sees cannot be completely suppressed no matter the magnitude of the bolt preload. However, by making the stiffness of the bolt low relative to the stiffness of the stub shaft flange the fatigue load that the bolt sees (ΔF_{bolt}) can be mitigated. Stiffness (or spring constant), K , is defined as:

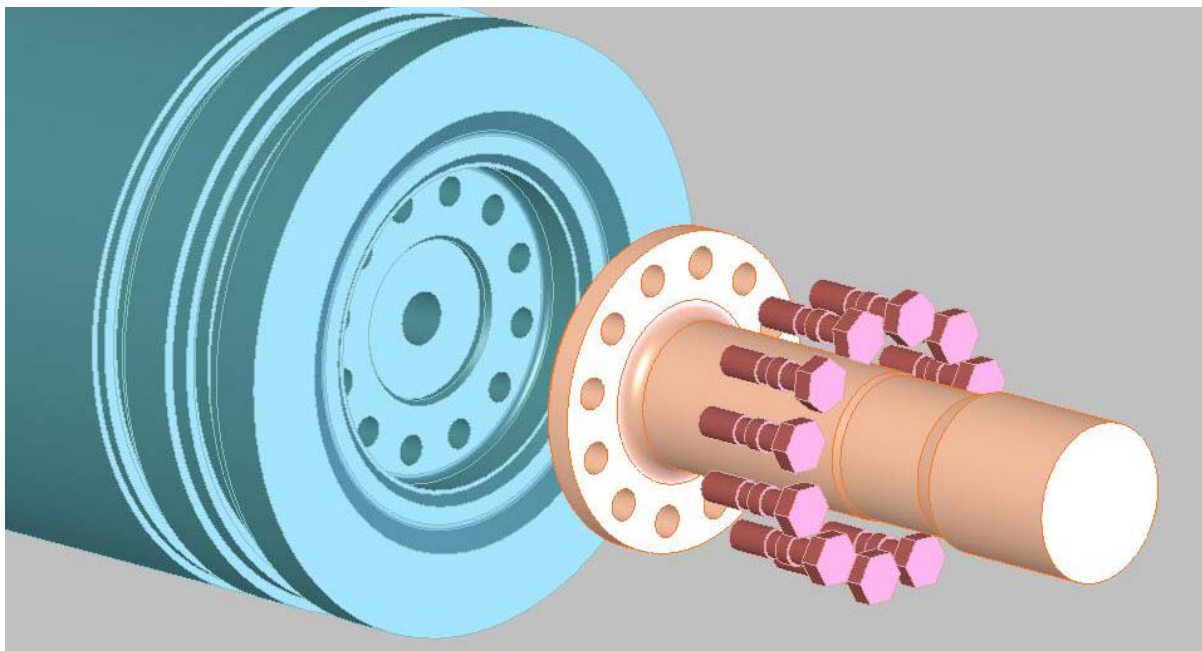
Figure 8. The stub shaft, bolting and LP Spindle component parts are shown disassembled.

A three dimensional model of the spindle was created in SolidWorks 2006 from measured dimensions. The separate component FEA models are shown in Figure 8, and the FEA assembly is illustrated in Figure 9. Using symmetry, half of the assembly was modeled. The assembly with bolt preload was analyzed in CosmosWorks 2007. The design required optimization in the LP spindle cavity, the stub shaft gland radius, the bolt circle diameter and the bolt diameter. FEA's were conducted with several rabbet fit diameters and bolt preloads. Stress values were tabulated for subsequent fatigue analyses.

Since the clearance between the LP spindle face and steam gland casting was very limited, the stub shaft was designed so that the bolt head did not extend beyond the LP spindle face. However, part of the LP spindle face was recessed as shown in Figures 8 and 9. The new design allowed the steam gland radius to be increased slightly from the original design to decrease the stress concentration of the radius. In order to get sufficient pressure between the LP spindle cavity and stub shaft flange from the bolt preload to prevent slippage in case of mis-synchronization, a large rabbet fit diameter was selected.

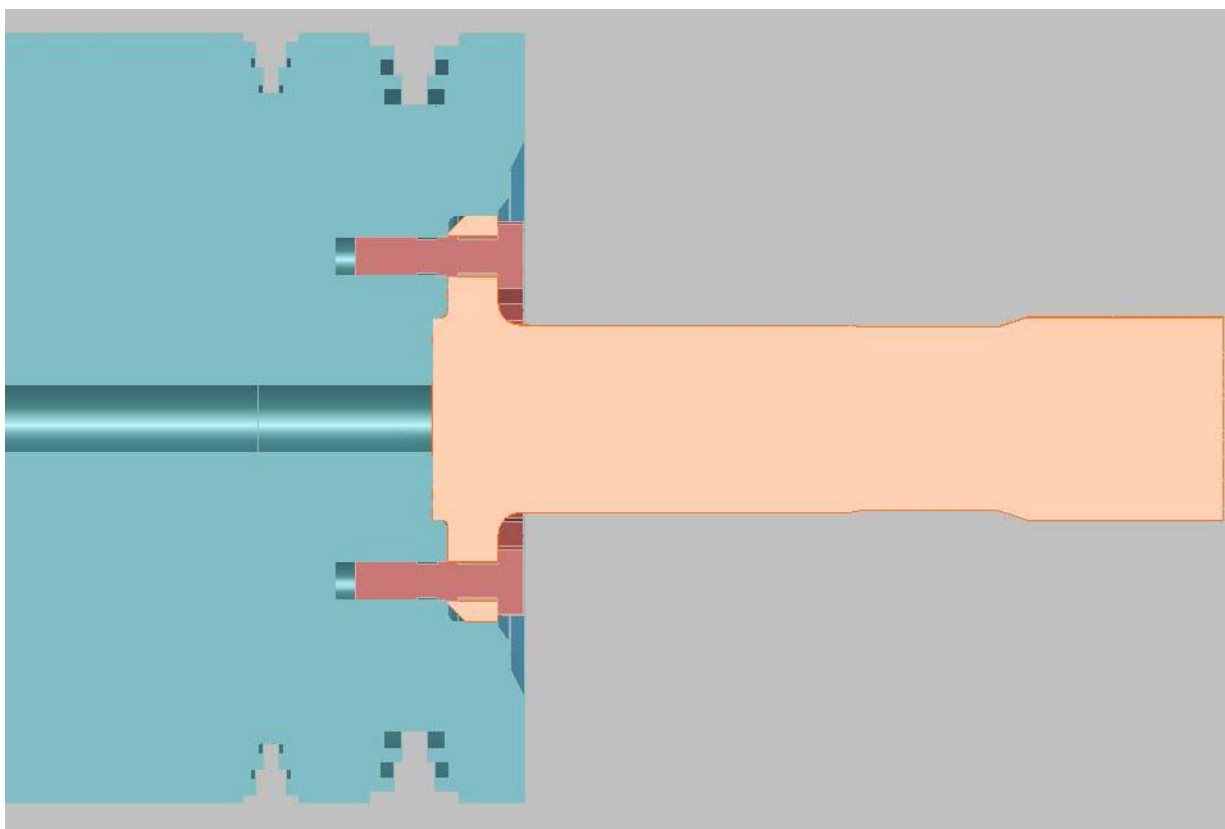
Figure 9. The stub shaft is assembled into LP Spindle cavity with 12 hex head bolts.
